Tom Wheeler, N0GSG
n0gsg@arrl.net
January 19, 2003

Pryme RD-78 VHF/UHF Dual Band Antenna: Short Circuit Problem Warning

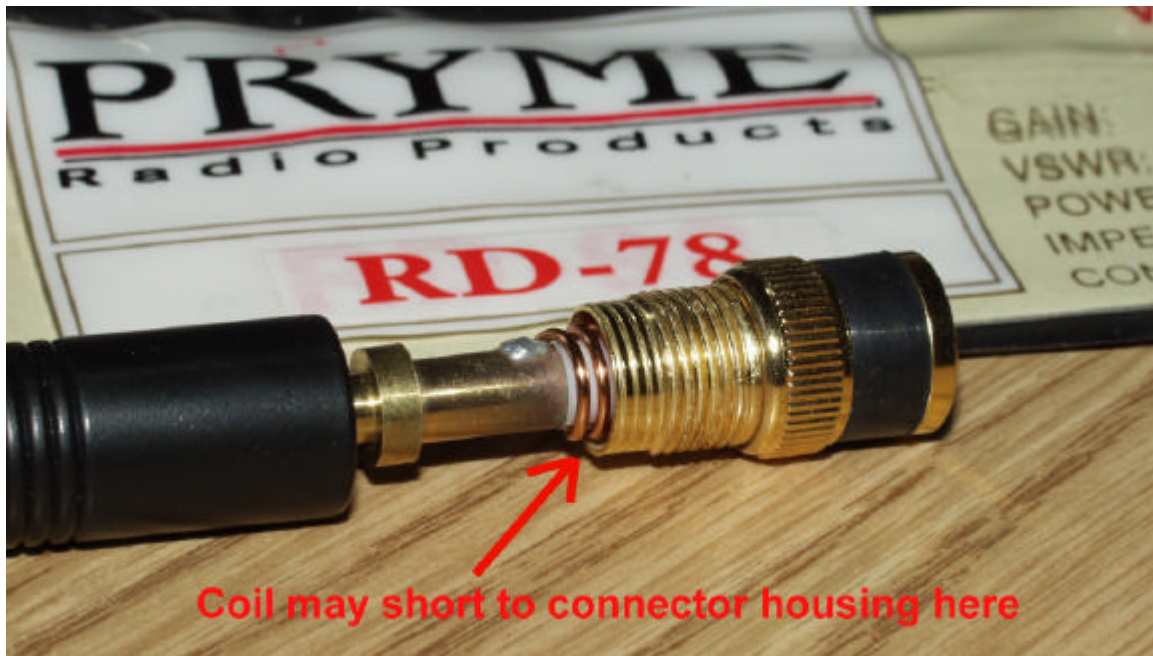
Users of this antenna should be aware that a potential short circuit exists within the connector and loading coil of the unit. Figure 1 illustrates the problem: The manufacturer has included a bare copper loading coil in the base of the antenna. When the antenna is in use, there is enough play in the assembly for it to touch the sides of the connector. This will result in an intermittent short being presented to the transceiver.

Figure 1: The loading coil is uninsulated and can short against the BNC connector body, resulting in possible damage to a radio in transmit.

To correct the problem, unscrew the plastic boot (at left in the figure above). You may need to gently grasp the BNC connector inner shield with needle nose to unthread the boot. There may be a small amount of glue on the threads. Remove the loading coil assembly, as shown in Figure 2.

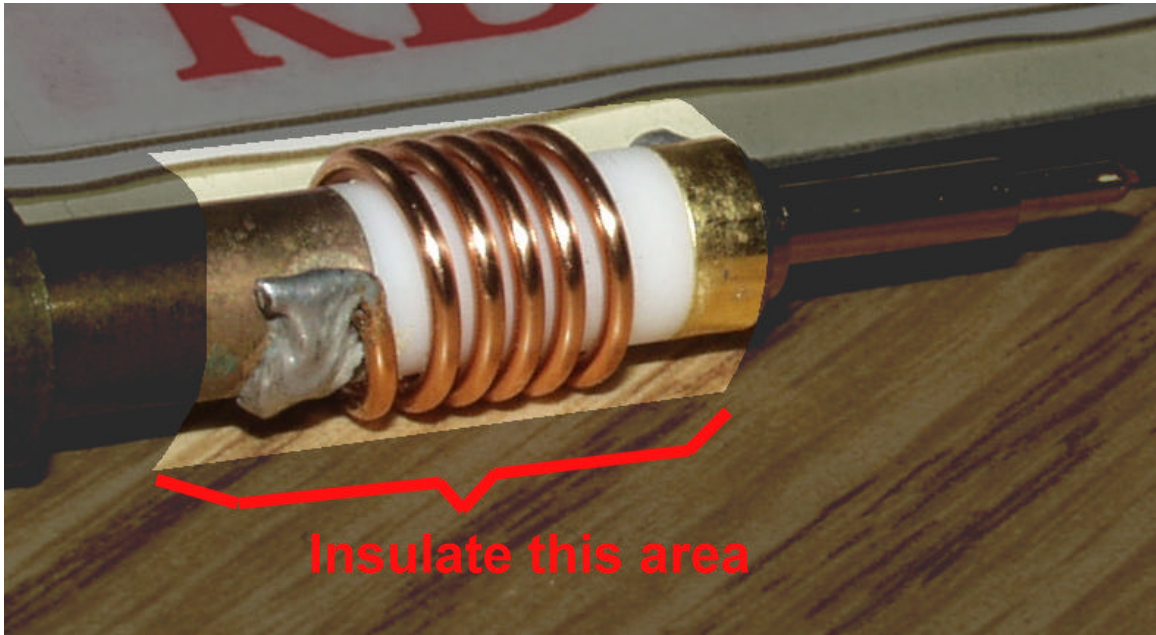
Figure 2: Add insulating material over the loading coil to prevent future shorts.

Apply heatshrink tubing (or any other suitable insulating material) over the loading coil, being careful to not bend the coil itself (or short its turns together). Inspect the two solder joints to make sure they're OK; the unit above had two cold solder joints. Finally, reassemble the antenna, and verify correct performance of the unit.
